## RECOMMENDATIONS RELATED TO BROWNS

### FERRY FIRE ブラウンズフェリー火災に関する提言

## 1.0 SUMMARY AND RECOMMENDATIONS 概要と提言

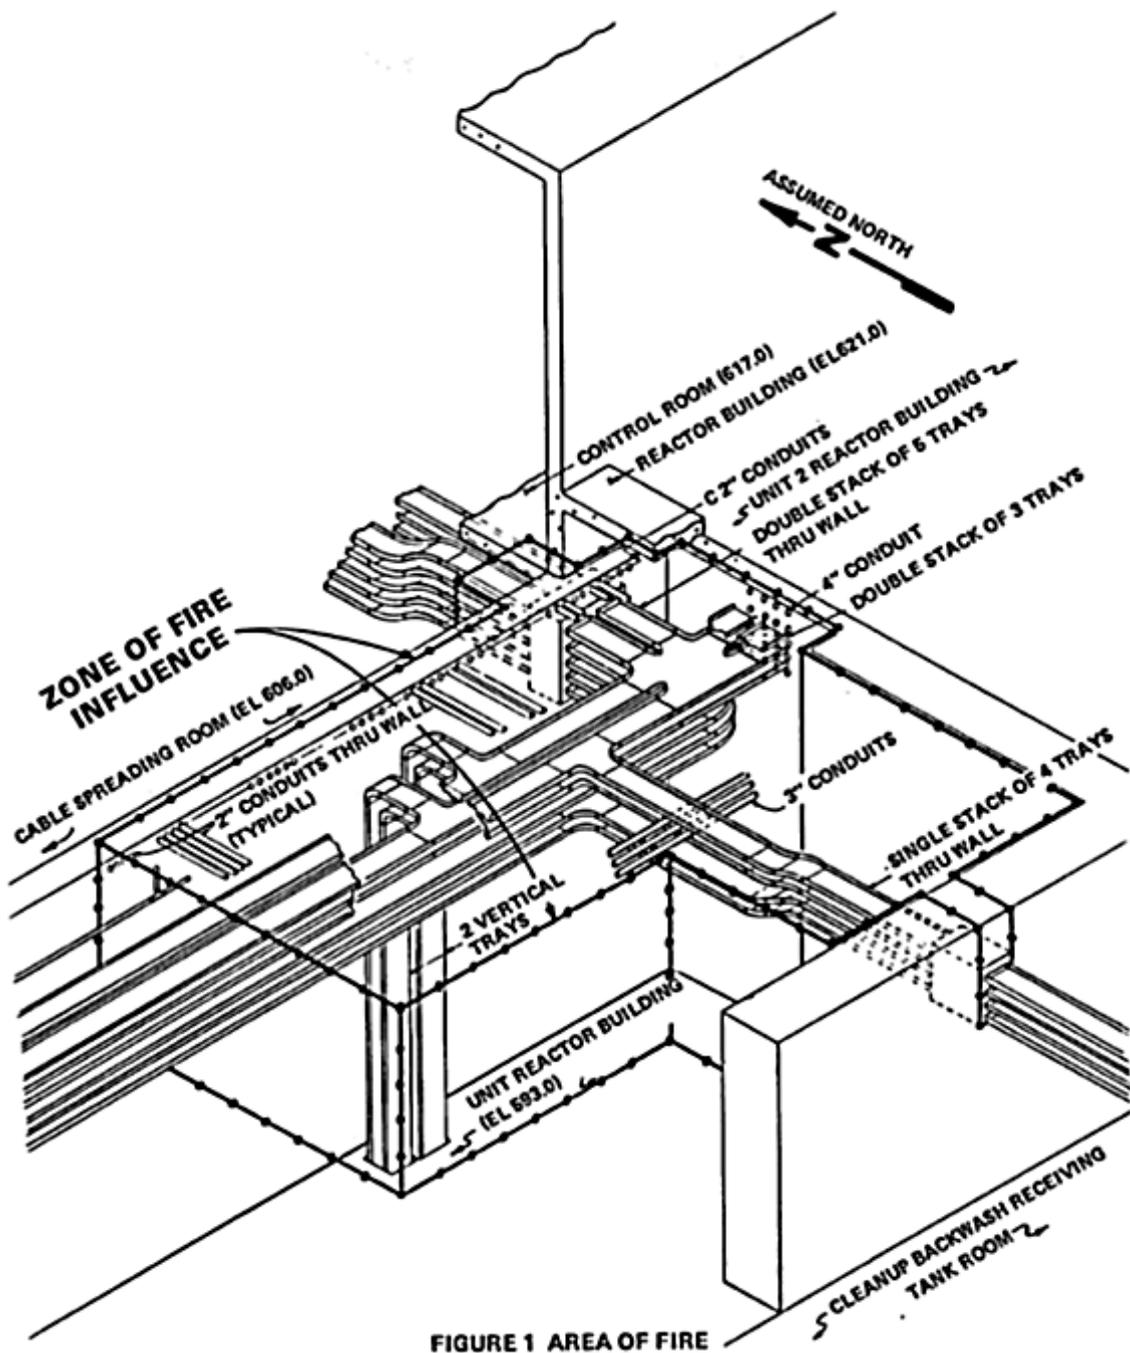
FIGURE 1 AREA OF FIRE

The fire originated in a cable tray penetration between the cable spreading room and the reactor building. Figure 1 shows the extent of the fire damage.

Cables and raceways were damaged for a distance of about five feet inside the spreading room.

The major damage occurred on the reactor building side of the penetration.

Visible damage was observed in the cables in a double stack of three trays south as far as a fire stop about 28 feet from the penetration and west along the double stack of five trays for a distance of about 38 feet.

Cables in four vertical trays were also damaged downwards for a distance of about 10 feet.

TVA has identified and tabulated 117 conduits, 8 conduit boxes, 26 cable trays and a total of 1611 cables routed in these trays and conduits that are damaged or assumed damage (11).
